Flow-Liner® EXTENDS PIPES LIFE

Cured-In-Place-Pipe Lining

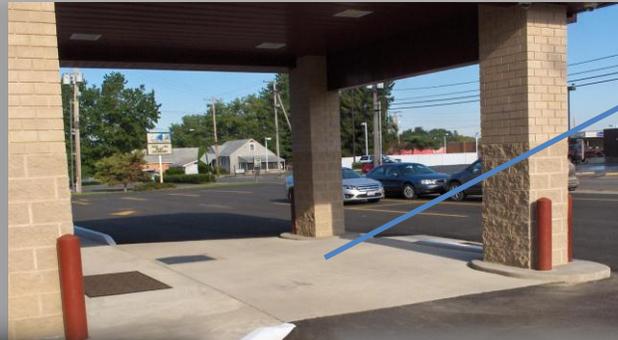
Before Picture
Showing
deteriorated cast
iron pipe bottom

Problem: A newly remodeled medical office had a badly deteriorated underground cast iron sewer pipe. In some locations of the cast iron the bottom of the pipe was missing due to excessive deterioration. The pipe was also heavily scaled and had become a drainage issue prior to the medical office's grand opening. The building was previously home to the local Social Security Office for over 40+ years.

Solution: A Certified Flow-Liner® Installer will re-line the main sewer pipe under the parking lot and canopy with the Flow-Liner® Cured-In-Place-Pipe lining system.

Result: The 165 ft. long cast iron sewer pipe was lined successfully. The parking lot and the main entrance canopy's concrete skirt were saved. Flow-Liner® resuscitated the existing pipe and extended its life span by a minimum of 50+ years with its Cured-In-Place-Pipe Lining System.

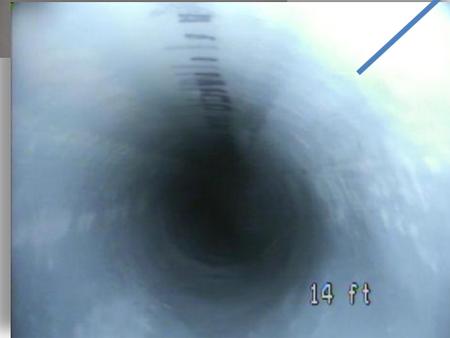
After Pipe was
lined with
Flow-Liner®
