## Innovative Flow-Liner® Technology “Flows” Under The West Wing

### Problem at The West Wing:

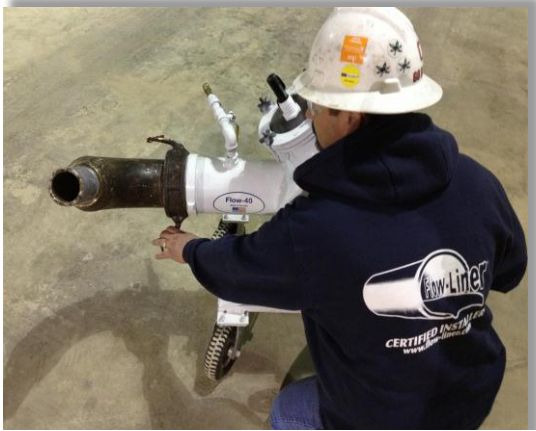
**Certified Flow-Liner® Installer preparing the conduit lining inversion unit**

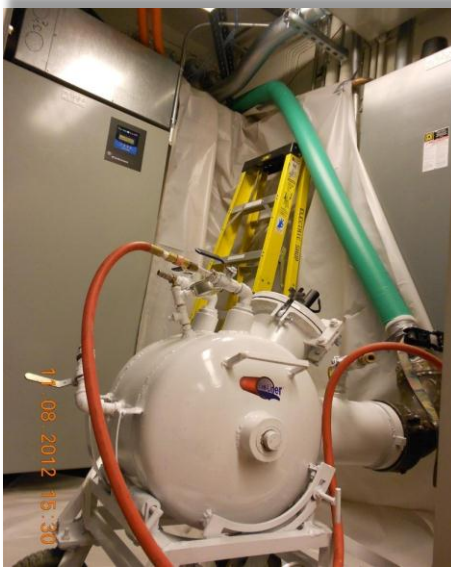
Flow-Liner® installation with the inversion unit set-up

The Flow-Liner CIP Conduit® was installed in less than one day. The walls and floors of the historical White House West Wing structure were unscathed. The telecommunications conduit lining saved the utility contractor a tremendous amount of labor and demolition. The Flow-Liner product also eliminated any inconveniences the demolition noise, dust and debris would have caused the President and his Staff.

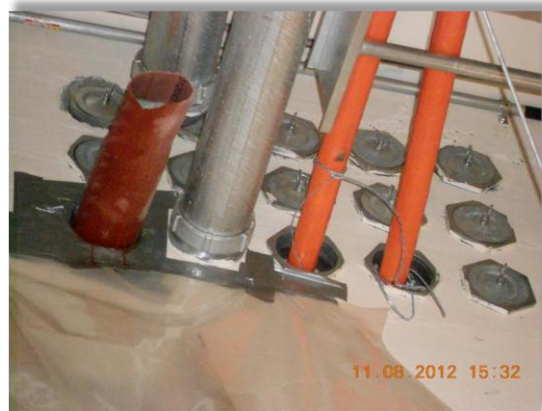
Picture of the Flow-Liner CIP Conduit® (on left) after it was inverted into the telecommunication conduit

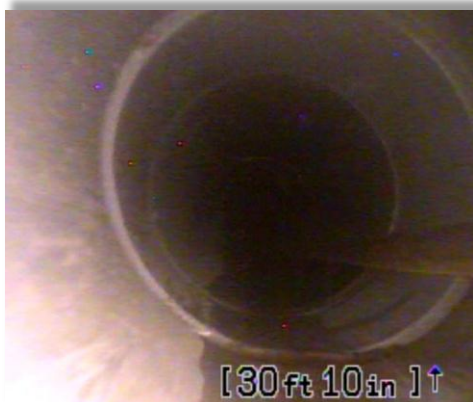
Picture of before the Flow-Liner® installation, showing water infiltrating into the bottom of the existing conduit

Before the lining crew could install the CIP Conduit® liner, they had to televise and inspect the inside of the conduit with a special video camera which is designed for this purpose. After inspecting the conduit with the video camera, the crew found the conduit ran approximately 45-50 feet under the first floor of The West Wing. It also had several bends in it traveling in different directions, but this was not a problem for the crew. They were on a mission and knew what had to be accomplished.

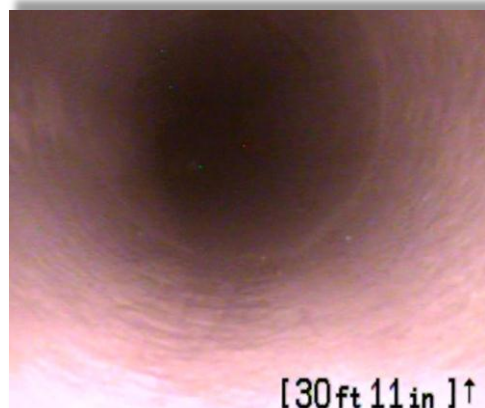
Picture of after Flow-Liner® was installed, sealing the joints and eliminating the water problem
