Flow-Liner®

“Under the Highway”

ODOT – DISTRICT EIGHT

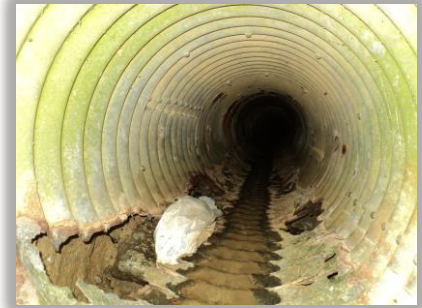
ODOT had an 18 inch galvanized culvert, approximately 87 feet running under a State Route located in Warren County. The culvert had several holes as a result of deterioration and was washing out.

Condition of culvert before lining

A certified Flow-Liner Installer, using Flow-Liner® technology, prepared the culvert and installed a CIPP Lining System in the 18 inch culvert.
