Flow-Liner®

“Dives in at the YMCA” With a Pipe Lining Technology Answer

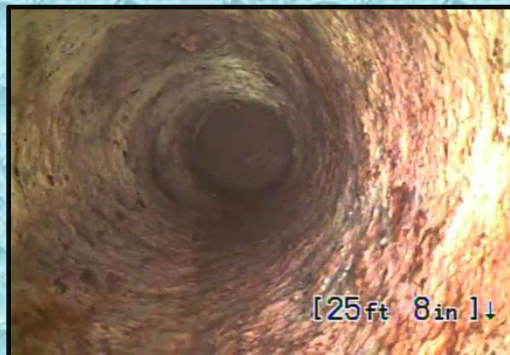
Drain pipe prior to lining

A leak was located in the 4” steel pool drain pipe that ran from the skimmer to the pump room. The line had two 45° bends and was located under the pool deck. Replacement of the piping would be very costly and would delay opening the pool and not considered an option.

Using Flow-Liner® technology, a Flow-Liner Certified Installer used the Flow-Liner Pipe Lining System to line the leaking drain pipe.

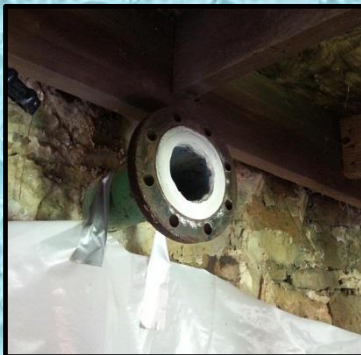
Drain pipe at pump house
after Flow-Liner® Liner

The pool drain pipe was successfully lined without excavation to the pool or pump house. The pool is on schedule for opening day for the Summer 2014 pool season.

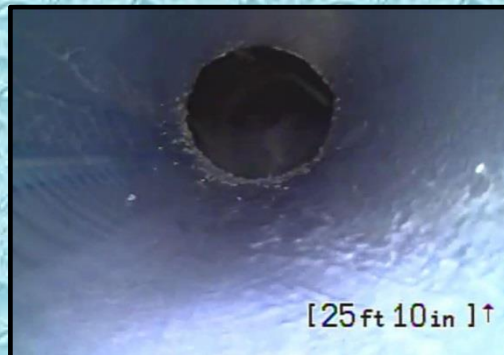
Drain pipe after Flow-Liner® Liner
